SR 3 MP 58.21 Unnamed Tributary to Hood Canal (991240): Preliminary Hydraulic Design Report

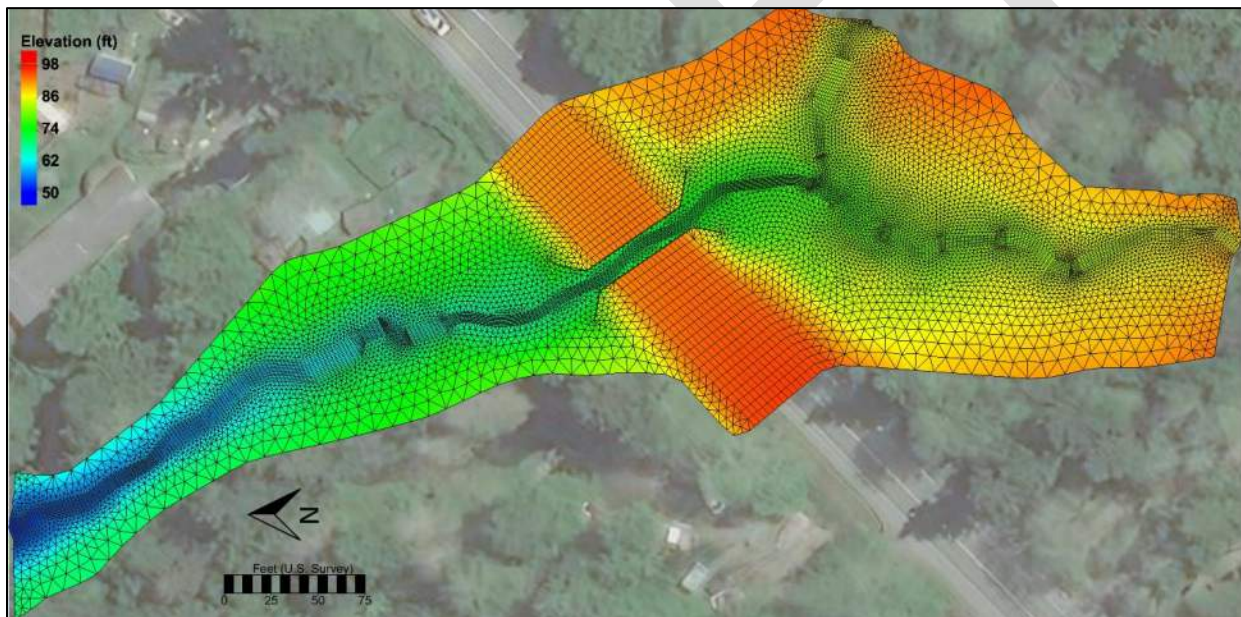
Figure 50. Proposed-conditions computational mesh with underlying terrain

Channel sinuosity generated from complexity features has been built into the proposed channel surface (Figure 50). Wingwalls of the proposed structure were also built into the survey surface and distinguished by closer node spacing along transitional features. Habitat features were represented as a compound roughness throughout the regions they occupy. This is most clearly evident in the Proposed Crossing Floodplain and the Proposed Channel Floodplain (Figure 51).

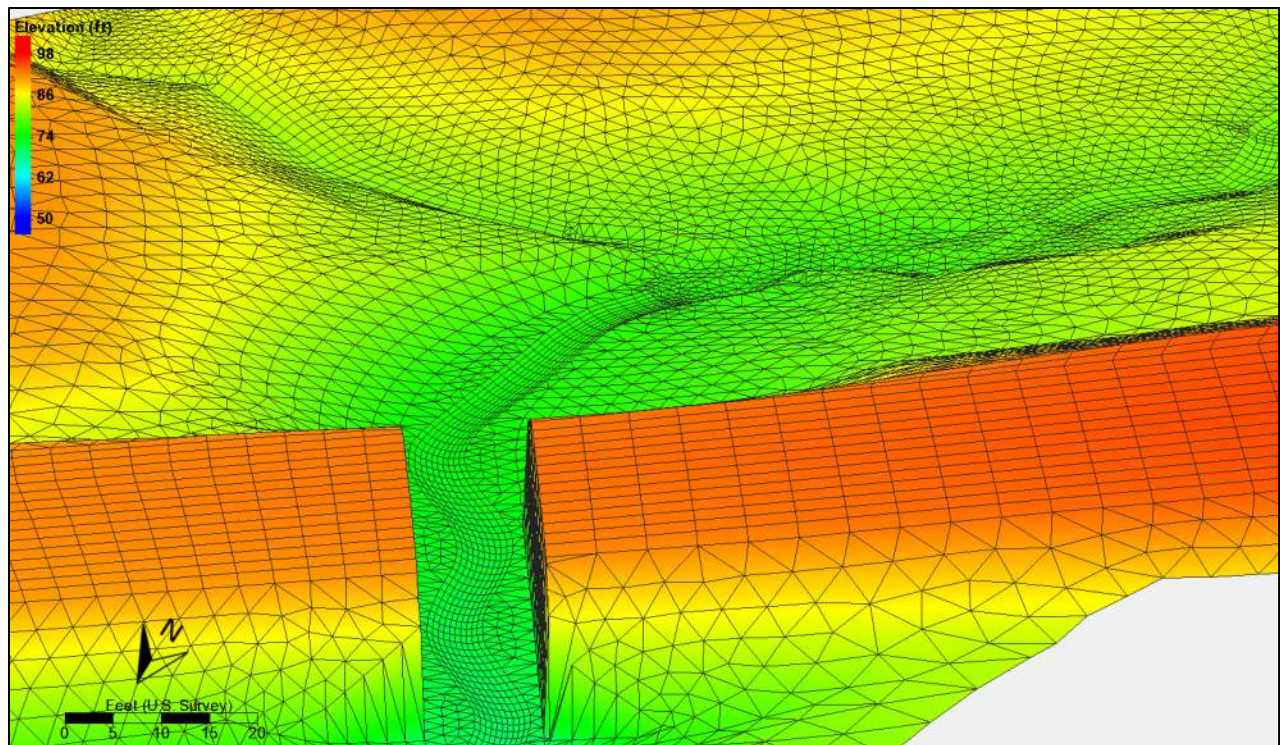
Figure 51. Proposed Mesh view of east tributary confluence

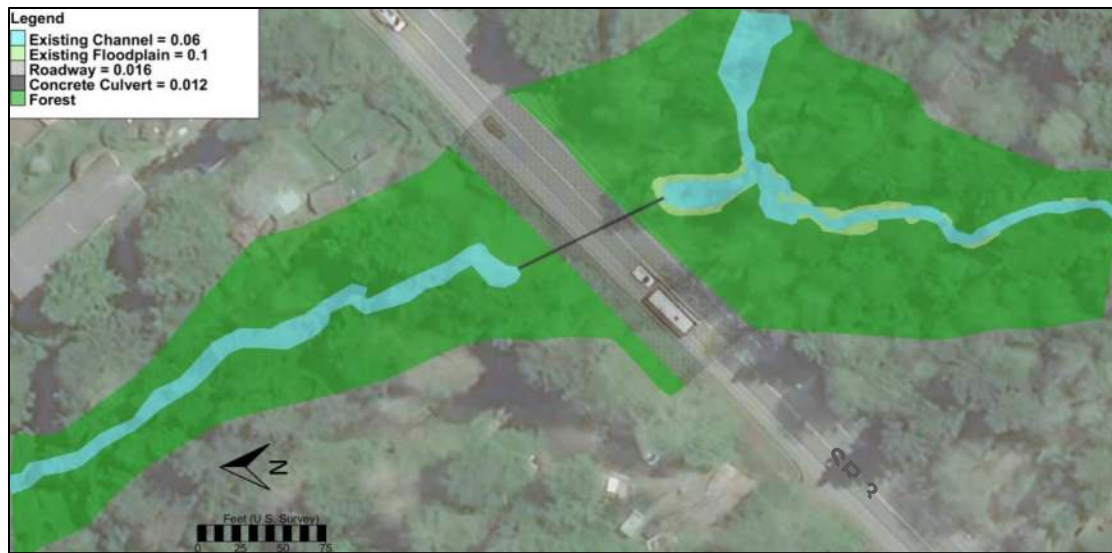
Figure 52. Spatial distribution of existing-conditions roughness values in SRH-2D model

Hydraulic roughness in the SRH-2D model is represented by Manning's n values. These composite values average the roughness within each coverage region. The existing and proposed model roughness conditions are divided into seven categories: Existing Main Channel, Existing Floodplain, Proposed Channel, Proposed Floodplain, Proposed Crossing Floodplain, Forest, and Roadway Table 11. Channel values were selected by using the U.S. Forest Service's Stream Channel Flow Resistance Coefficient Computation Tool (the spreadsheet tool) (Yochum, 2018). The spreadsheet tool combined tabular, semi-quantitative, and fully quantitative estimates. This tool averages tabular estimates to provide an overall average roughness value. Floodplain values came directly from tabular guidance from the WSDOT Hydraulics Manual (WSDOT, 2022a). Tabular values with descriptions matching the field observations in Section 2 were chosen.

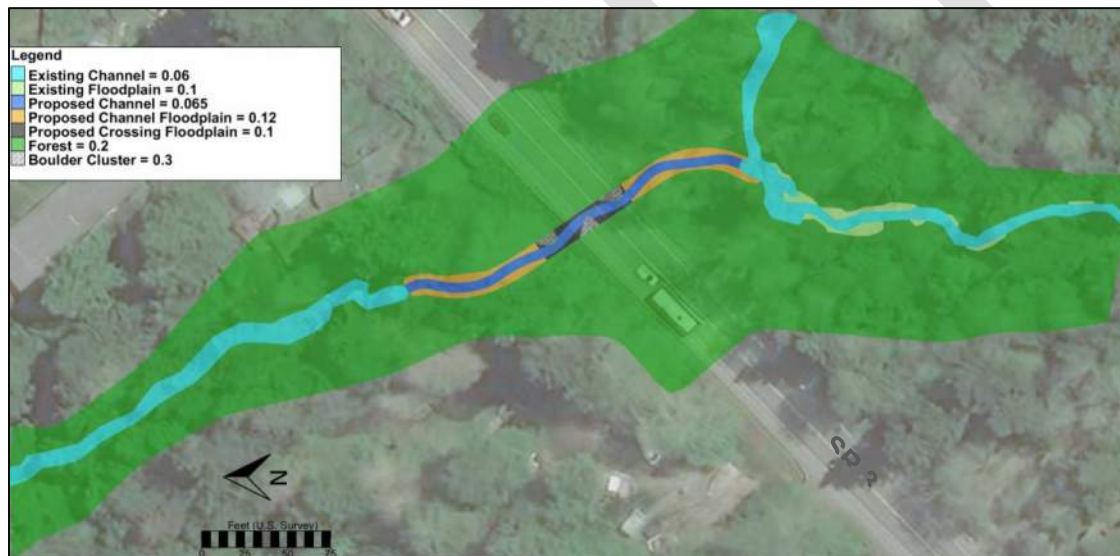
Figure 53. Spatial distribution of proposed-conditions roughness values in SRH-2D model

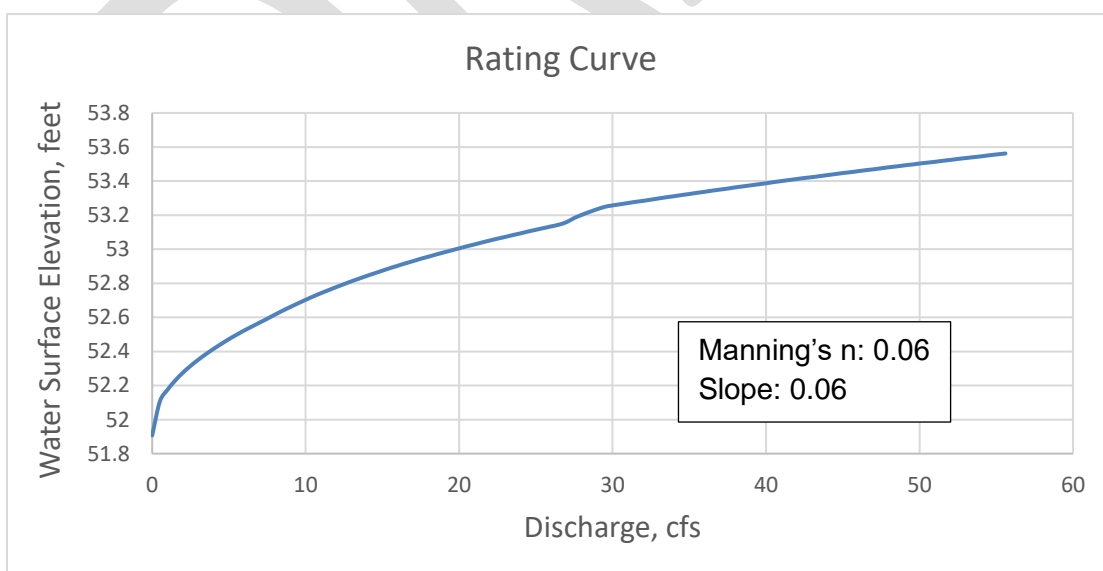
Figure 56. Downstream outflow boundary condition normal depth rating curve

The downstream rating curve is shown in Figure 56. This boundary condition was used in both the existing and proposed-conditions models. The locations of the boundary conditions in the existing and proposed-conditions model are shown in Figure 57 and Figure 58 respectively.

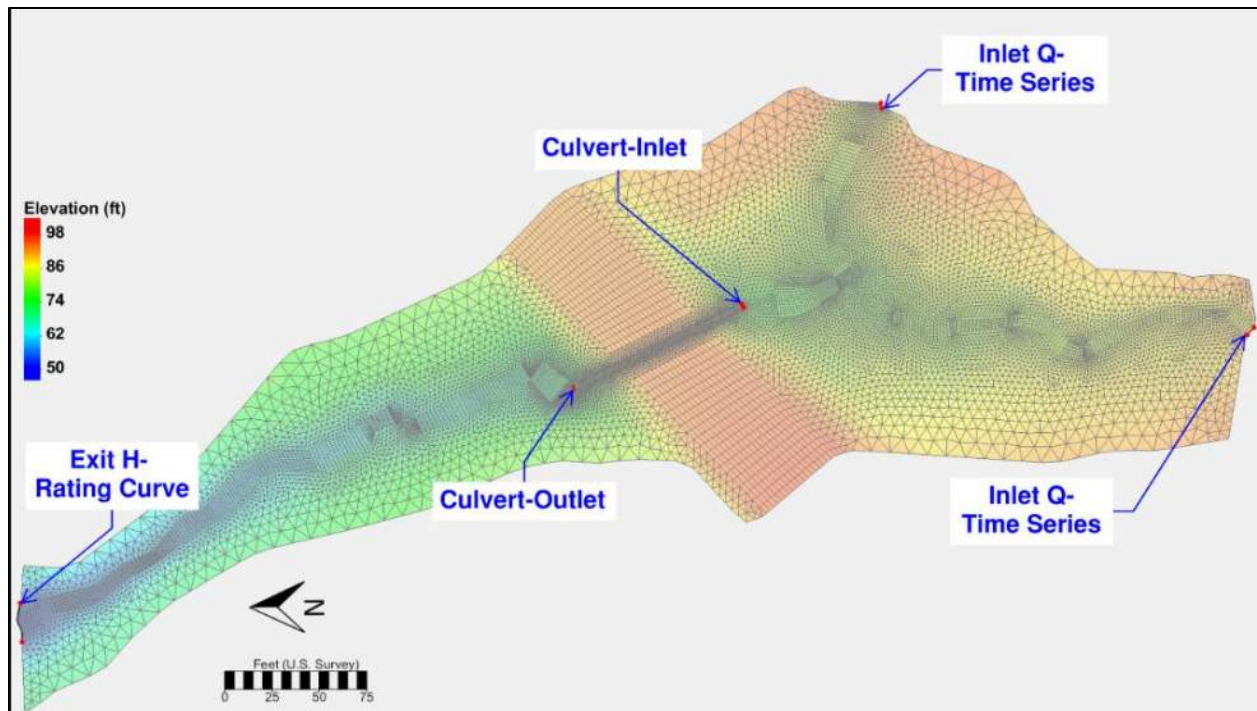
Figure 57. Existing-conditions boundary conditions

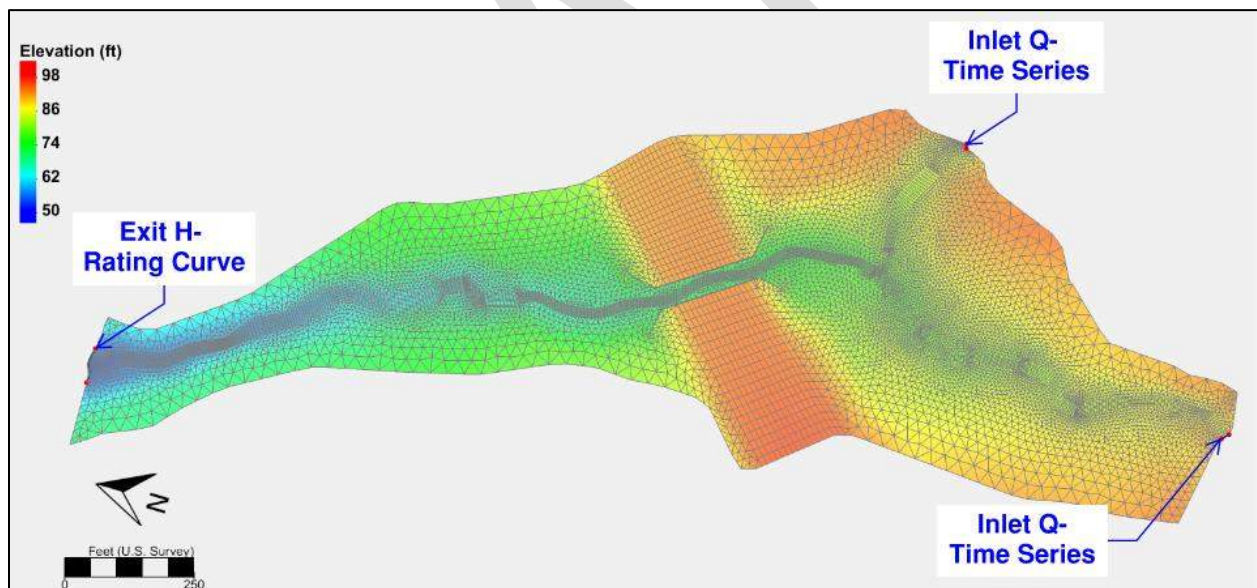
Figure 58. Proposed-conditions boundary conditions

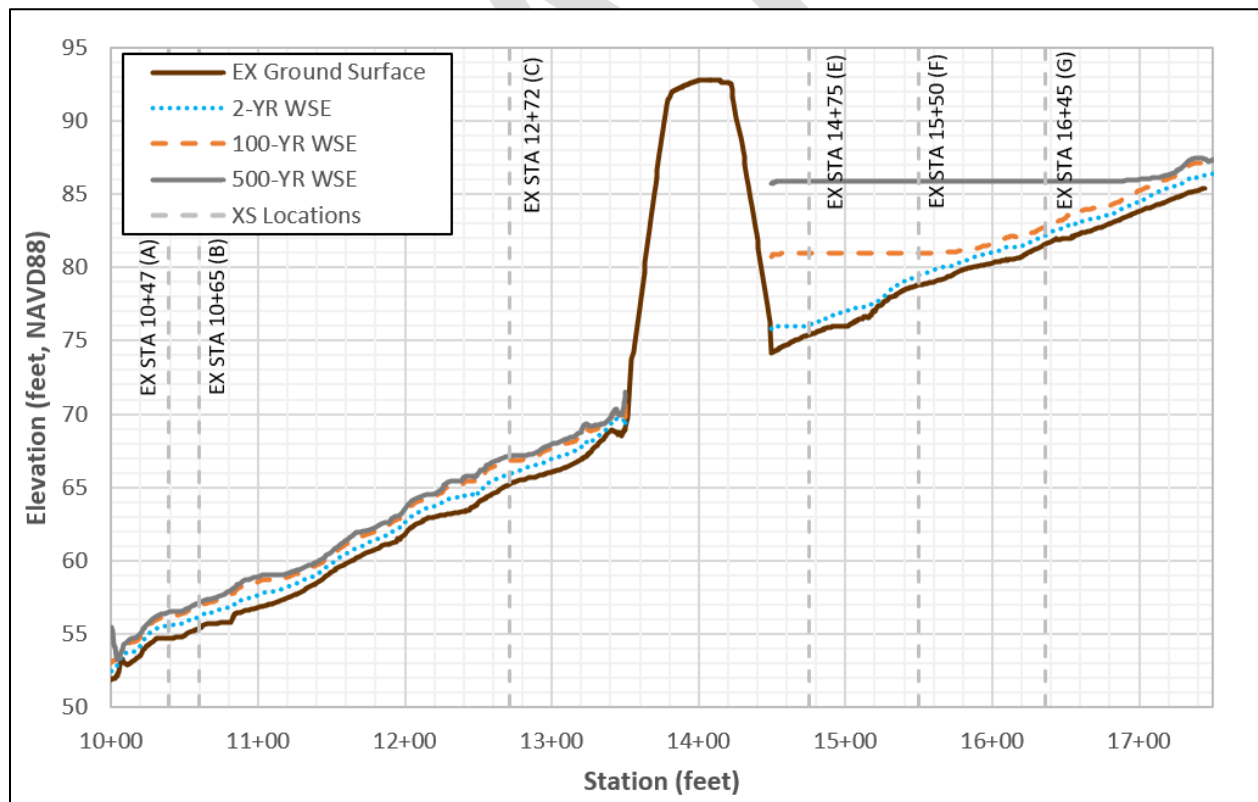
Figure 60. Existing-conditions water surface profiles

The 100-year flow produces a backwater condition that extends 132 feet upstream of the inlet to EX STA 15+80. Ponded water also extends up the east tributary channel for approximately 33 feet. Flooding expands to a maximum of approximately 53 feet wide at EX STA 14+48. A profile showing the results of the inundation for the 2-year, 100-year, and 500-year flows is shown in Figure 60.

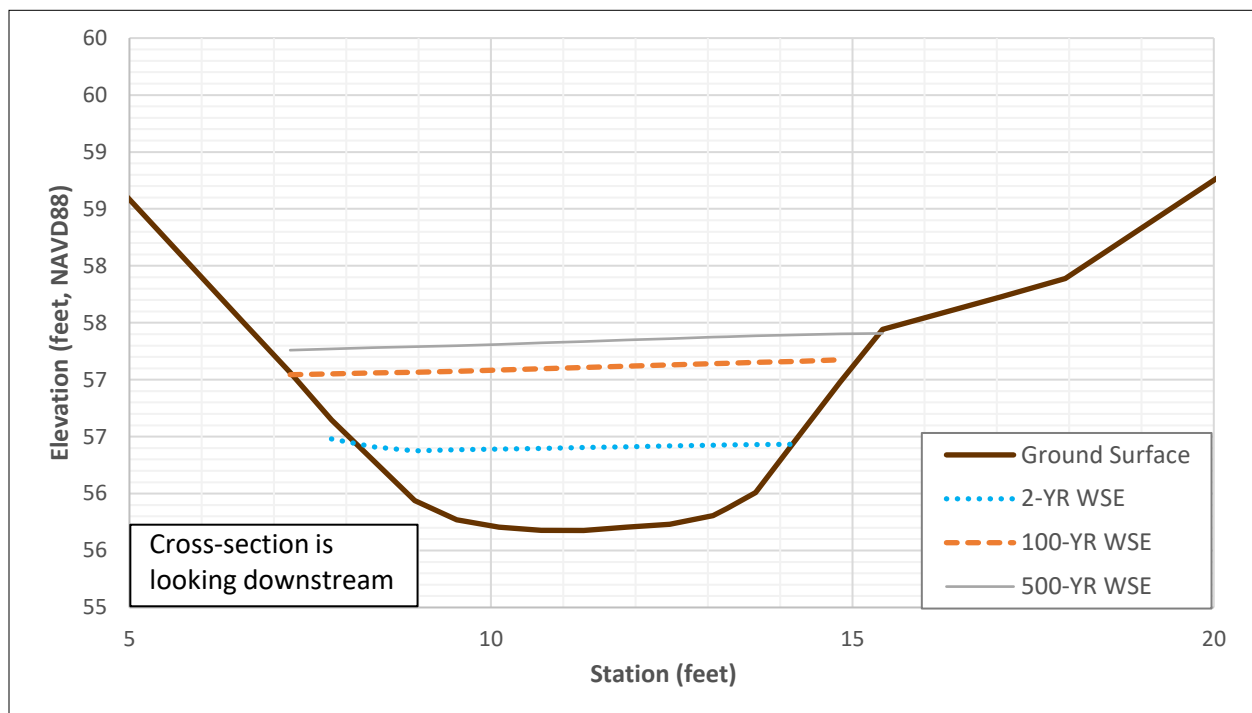
Figure 61. Cross-section near DS BFW #6 STA 10+47 (A) looking downstream

Figure 61 shows the WSE of the 2-, 100-, and 500-year flow event at cross-section (A) which is close to the beginning of the DS design reach. DS BFW #3 is located approximately 30 feet

upstream of cross-section (A). The channel has incised, causing the 2-year flow to be considerable below the defined right bank.

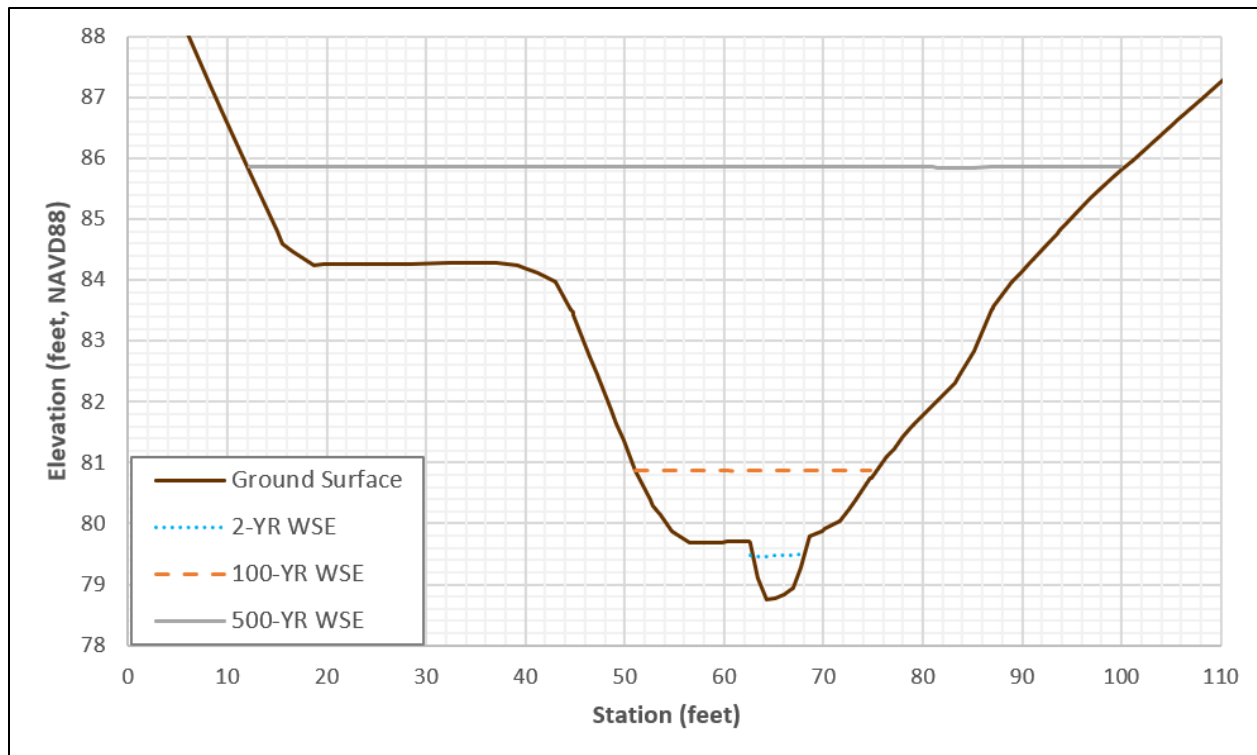
Figure 62. Cross-section at STA 15+50 (F) looking downstream

Cross-section (F) was drawn at EX STA 15+50 (US BFW #1) which is approximately where the downstream end of the US design reach begins. The 2-year flow width at this location is 5.2 feet which is 0.2 feet greater than the BFW measured at site visit 2. The measured bankfull depth 0.8 feet which is 0.1 foot lower than the existing condition modeled 2-year flow depth. These results verify that the existing-conditions model has similar flow characteristics at this flow, as would be expected from site data and observations. Note, the 100-yr and 500-yr water surface elevations at this cross-section are within the area of backwatering from the culvert and are thus higher than they would be in free-flowing conditions (see Figure 60).

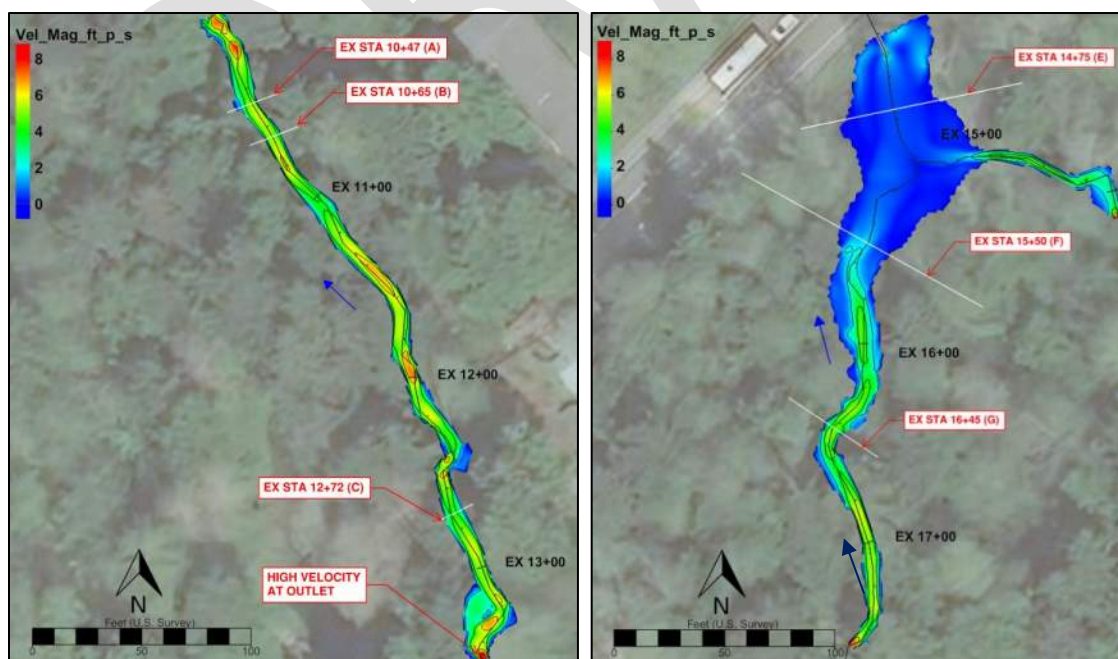
Figure 63. Existing-conditions 100-year velocity map with cross-section locations

Velocities of approximately 10 fps are observed at the culvert outlet. This is caused by the steep culvert slope of 5.1 percent, which is the reason the crossing is a fish passage barrier (Section 2.1). This explains the approximately 1-foot-deep scour hole at the culvert outlet (Figure 14). Figure 63 shows the extent of upstream flooding at the 100-year event.

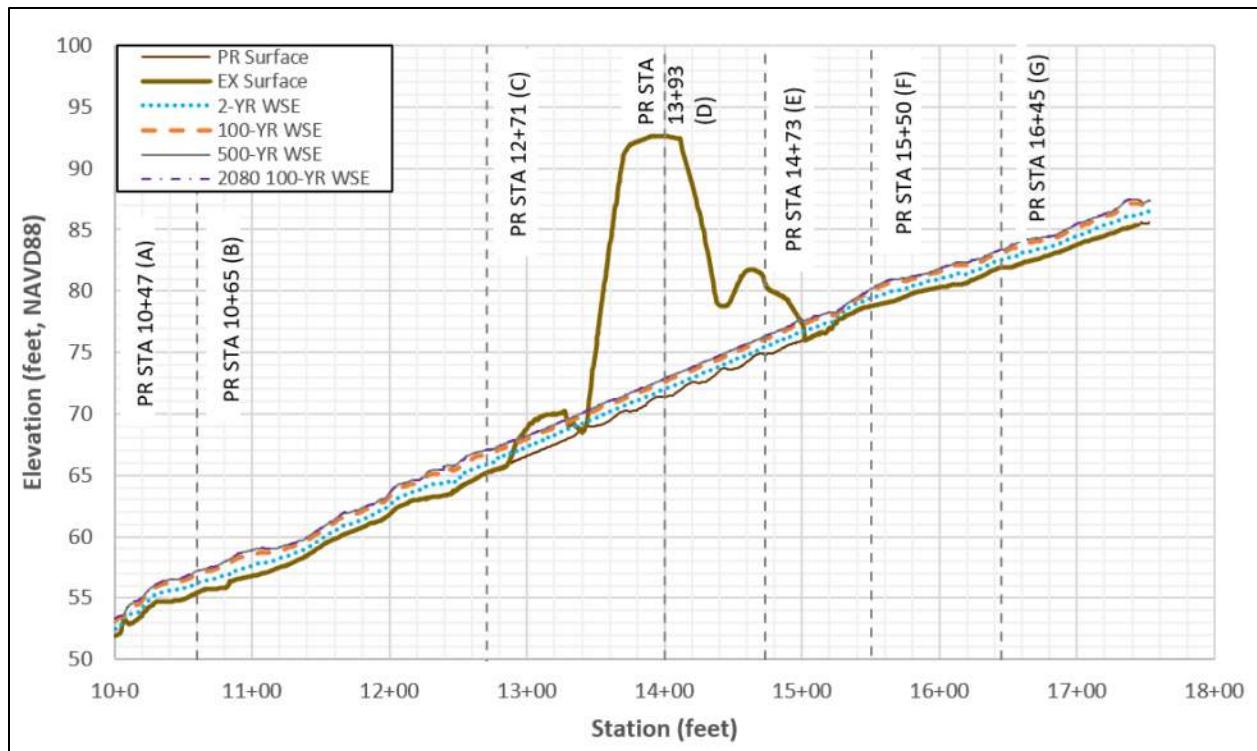
Figure 65. Proposed-conditions water surface profiles

Figure 65 shows the proposed WSE steadily follows the proposed grading and maintains a 100-year flow depth ranging from one to two feet. The 2-year flow width within the crossing is 5.8 feet, which is slightly higher than BFW 1# which is within the upstream design reach (Figure 66).

As illustrated in Figure 65, the 2-year flow is close to the top of the main channel bank, while the 100-year flow overtops the proposed overbanks by several inches. Because the meandering bankfull channel is built into the mesh within the crossing, that depth is only shown on the left bend. The 100-year velocity within the structure is within 0.4 fps of the velocity in the upstream design reach.

The 100-year flow does contact the sidewalls of the crossing structure at a maximum depth of 0.5 feet and the climate change 2080 100-year flow reaches a maximum depth of 0.9 feet up the side of the structure wall (Figure 66). The proposed model results indicate a 2-year flow depth and width of approximately 0.8 feet and 10.2 feet, respectively. The flow width is larger than measured BFWs because the 2-year flow slightly overtops the proposed channel banks (Figure 65).

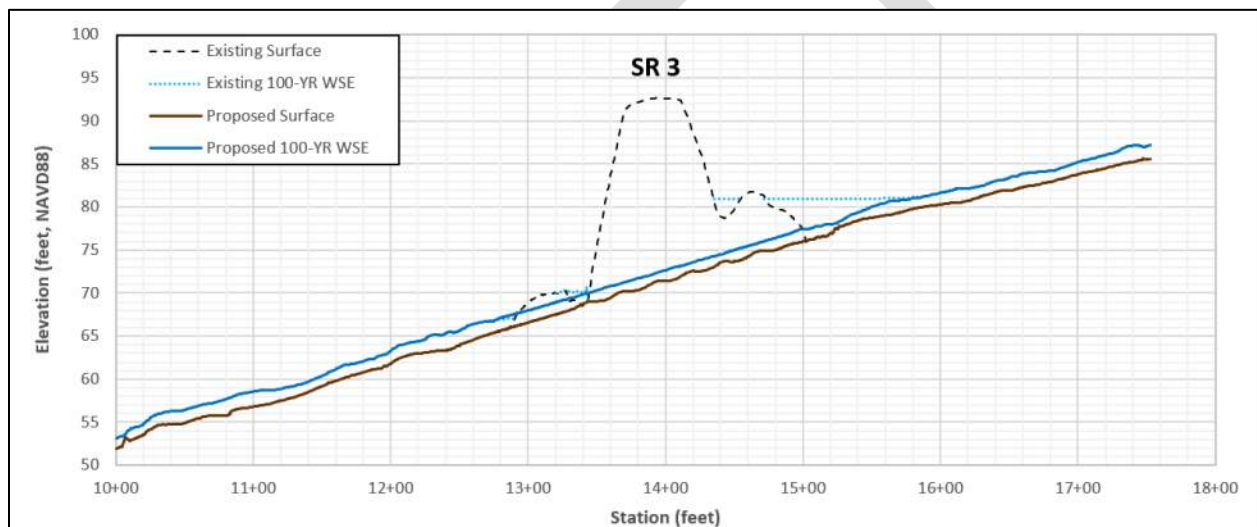
Figure 68. Existing and proposed conditions 100-year water surface profile comparison along proposed alignment

In the existing-conditions iteration, the existing 2-foot culvert causes backwatering at the 100-year flow event for about 140 feet upstream of the project culvert (Figure 68). Upstream from there the existing and proposed WSEs closely match. With the proposed crossing in place the model shows a drop of about 6.4 feet in WSE immediately upstream of the crossing. The two WSEs converge within 20 feet of the downstream regrade extent and remain virtually identical in the remainder of the downstream reach.

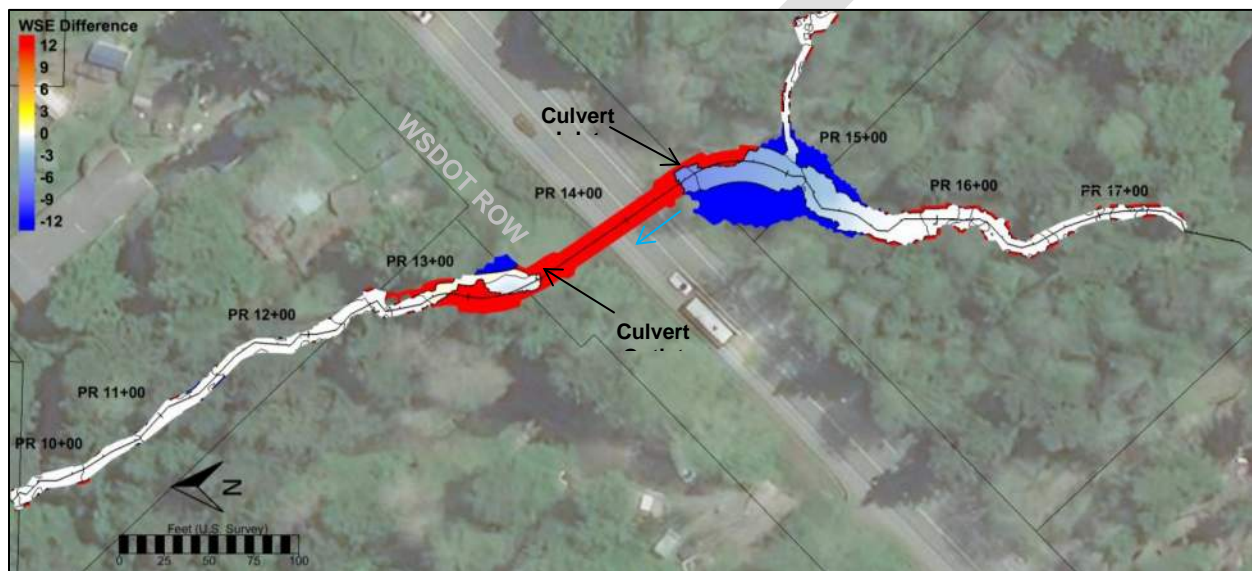
Figure 69. 100-year WSE change from existing to proposed conditions

The change in WSE between existing and proposed conditions at the 100-year flood event is shown in Figure 69. Negative numbers (represented by shades of blue colors) show where the future conditions water depth is lower than the existing condition water depths, while positive numbers (represented by yellow to red colors) indicate the opposite. The dark blue fill in Figure 69 shows newly dried area around the culvert inlet as the proposed crossing reduces the inundation caused by the backwater condition. The red fill in Figure 69 shows the newly inundated area created by the proposed regrading. There is no infrastructure within the limit of newly inundated area. No risk is posed to properties or infrastructure in the proposed conditions. A flood risk assessment will be developed during later stages of the design.

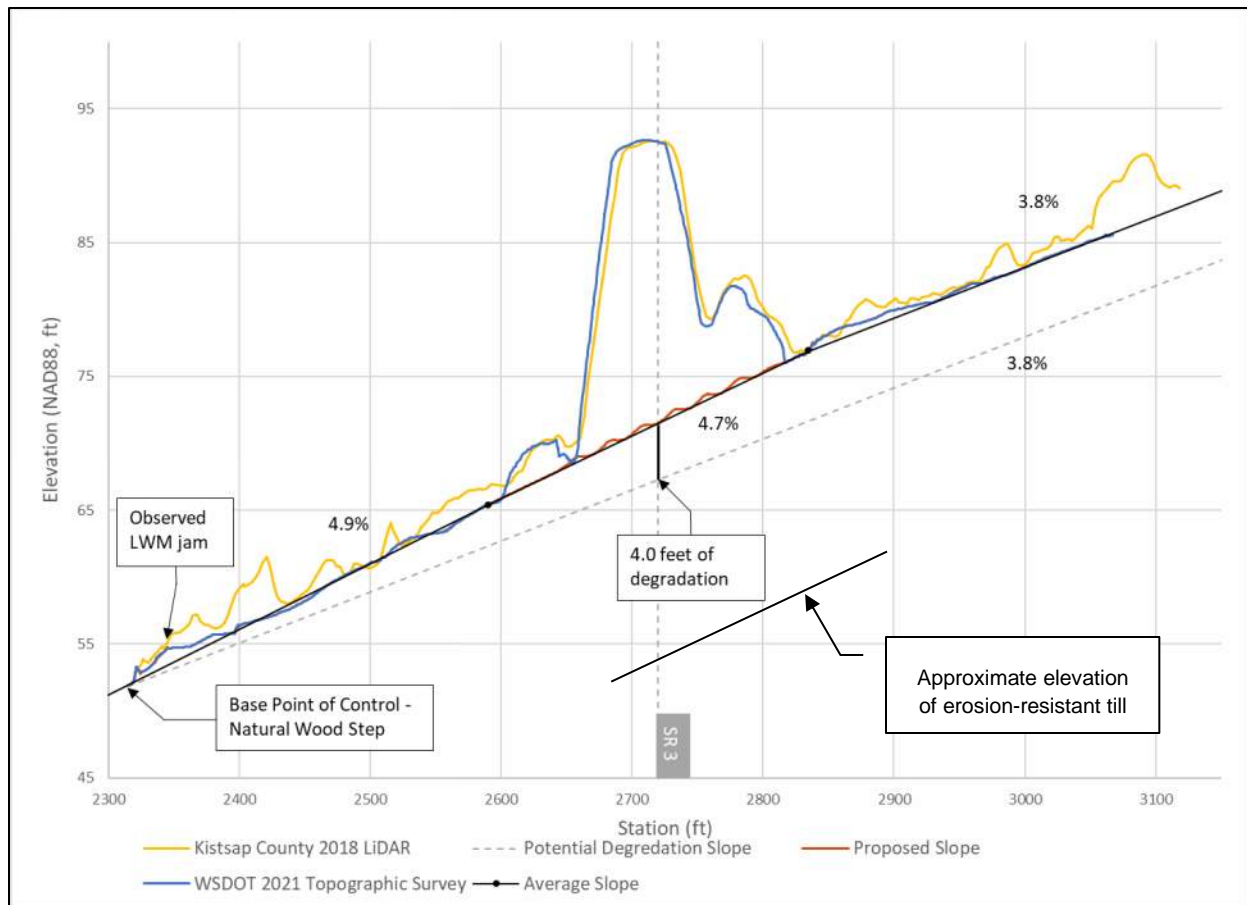
Figure 70. Potential long-term degradation at the proposed structure

The average long-term gradient through the SR 3 crossing is estimated to be 3.8 percent by projecting the slope of the downstream reach. The straight, regraded channel slope is steeper at 4.7 percent. The base level control occurs downstream at a hydraulic controlling LWM step (Figure 26). Projecting the 3.8 percent slope from the downstream base level control point results in an estimated degradation upstream of 4.0 feet (Figure 70). The upstream catch point of the slope is unknown and does not impact degradation depth at the crossing. The Kitsap County LiDAR profile runs along the existing alignment. The WSDOT topographic survey travels along the proposed alignment. The long-term degradation estimate is a conservative estimate based on the potential knickpoint migrating at least 530 feet upstream through the crossing structure. The terminus of the potential head cut is not known, but it is assumed to be upstream of the proposed crossing.

The preliminary geotechnical report boring data shows the first approximately 17 feet of soil is made of a roadway fill and cohesionless, coarse-grained very loose, silty sand from glacial deposits (WSDOT Geotechnical Office, 2022). The next 18- to 43-foot segment of soil (approximately elevation 53 feet to 27 feet) consists of cohesive, fine-grained, hard, sandy silt and stiff clay. The upper portion of this unit is estimated to be an erosion-resistant glacial till layer that would limit erosion, although based on the preliminary data it is below the potential long-term degradation depth.

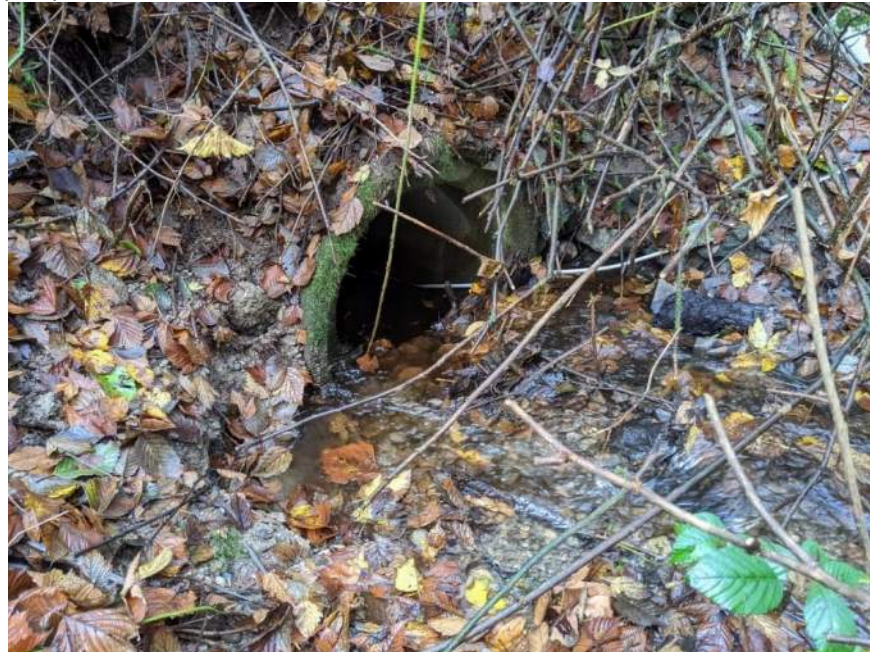
Photo 1. Existing culvert inlet

The crossing inlet is covered by dense brush and is partially filled with organic debris and sediment (Photo 1). Upstream of the crossing, the stream channel is approximately 5 to 10 feet wide and there is a floodplain bench approximately 1 to 2 feet above the stream channel for the majority of the surveyed reach. The wetted width on the day of the site visit was approximately 5 feet, although it appeared recent higher flows had been much wider and spilled out onto the floodplain in areas. Surrounding the inlet and extending from the top of the roadway prism to approximately 50 feet upstream of the inlet is a dense thicket of vegetation that crowds around the channel (Photo 10). The East Trib joins the main channel in this thicket of vegetation. The slope in this section of the river is low and main channel banks gently slope upward and transition into the surrounding floodplain.

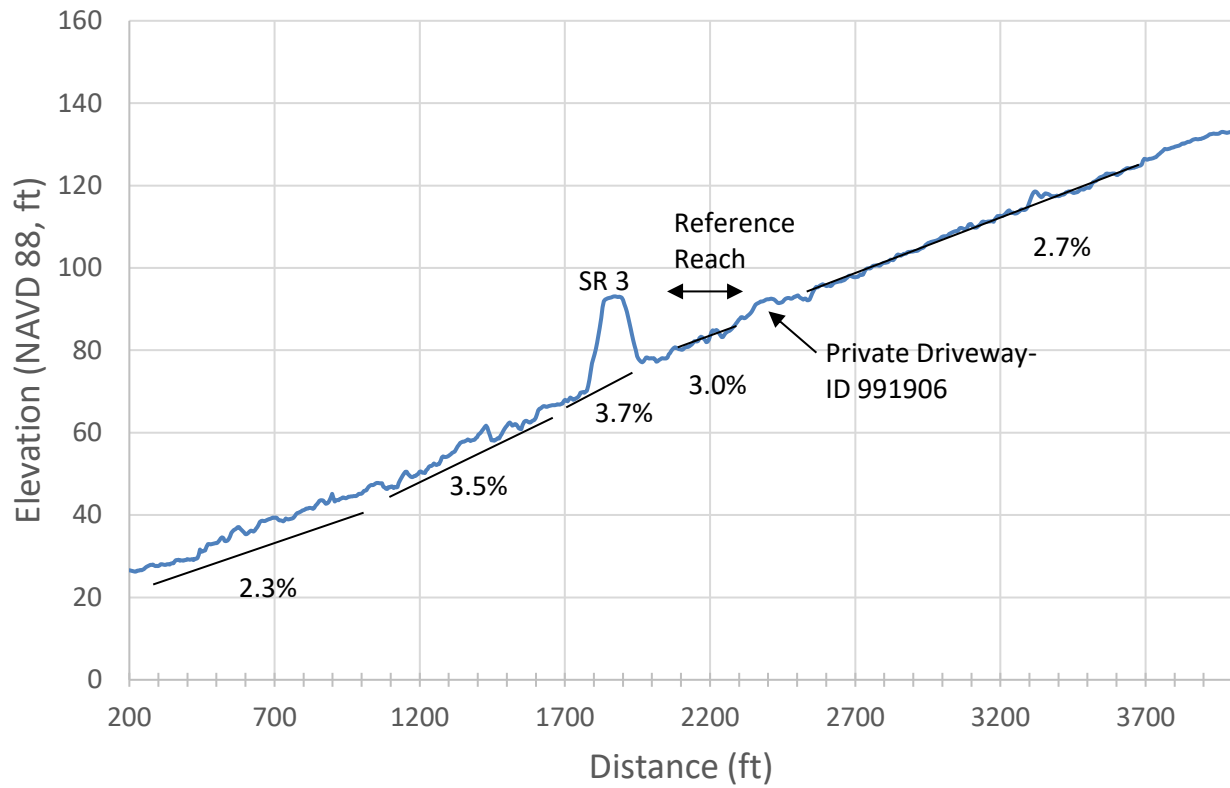
Photo 4. Watershed longitudinal profile

Crossing 991240 LiDAR Watershed Elevation Long Profile

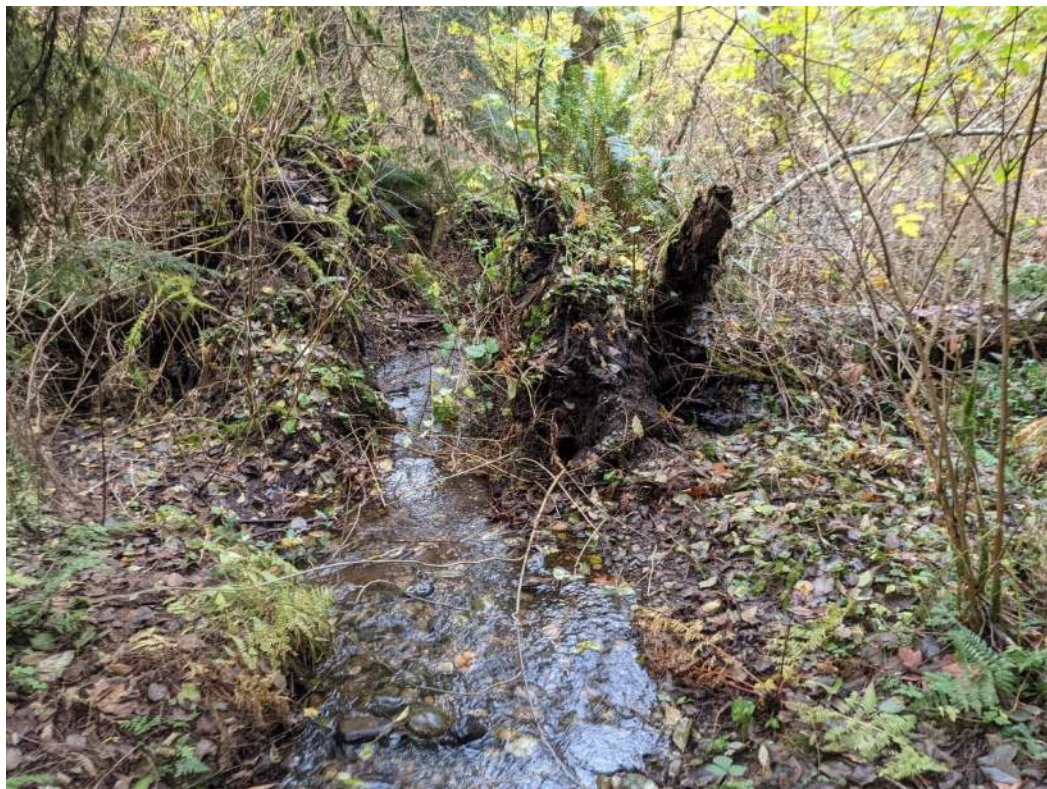
Photo 11. Main channel flows around a rootwad in upstream reach

For the next ~80 feet (from ~50 ft to ~130 ft from the inlet) the slope steepens and the stream is dominated by forced pool-riffle morphology. In this section there is forced sinuosity as the stream flows around several rootwads and LWM (Photo 11 and Photo 12), and the banks are steeper and more defined (Photo 13). At ~130 feet from the inlet there is a floodplain that extends to the west approximately 20 feet from the channel. At higher flows it is likely that the stream is well connected with this floodplain. Opposing this floodplain is a toe log following the bank (Photo 14) acting as a steep bank. The following section of river returns to riffle morphology, with established banks and benches on the sides (Photo 7).

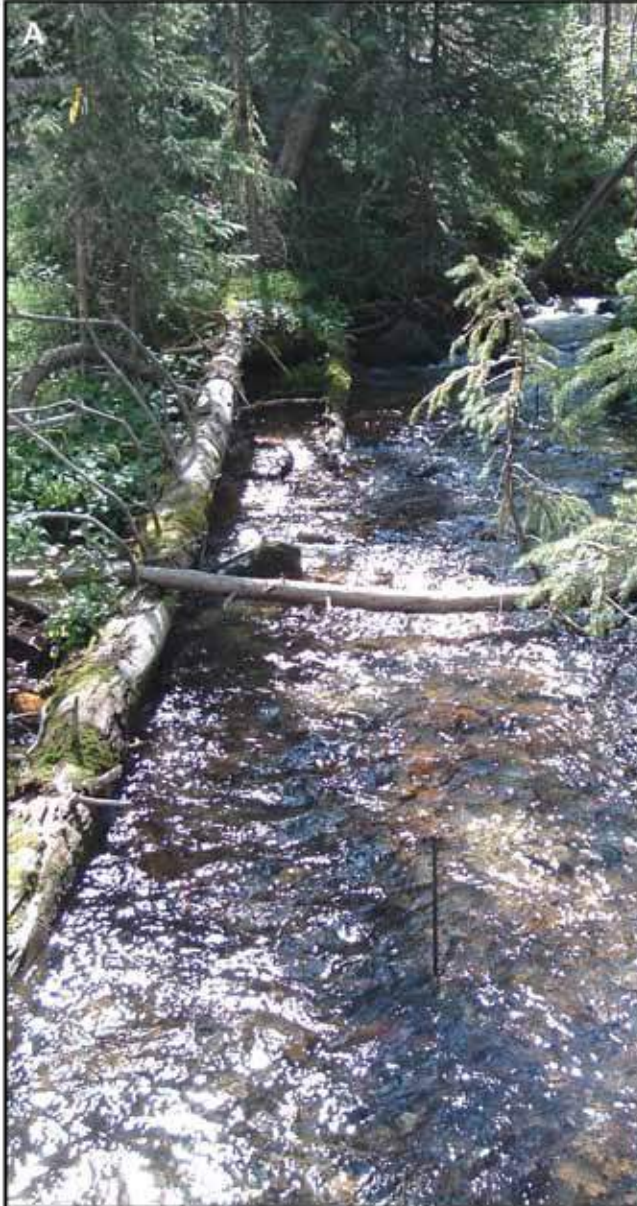
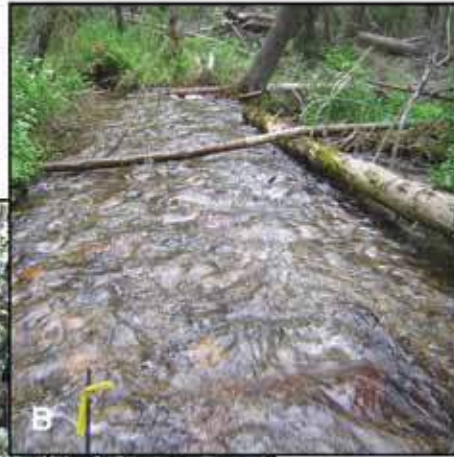
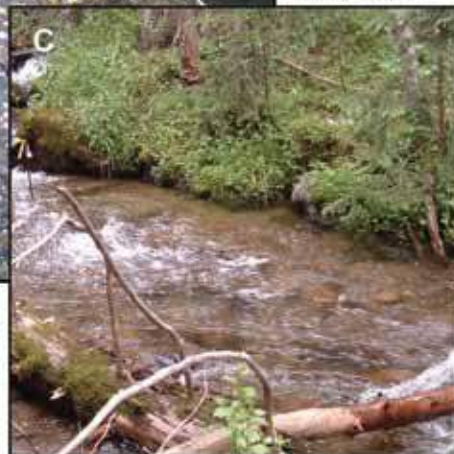
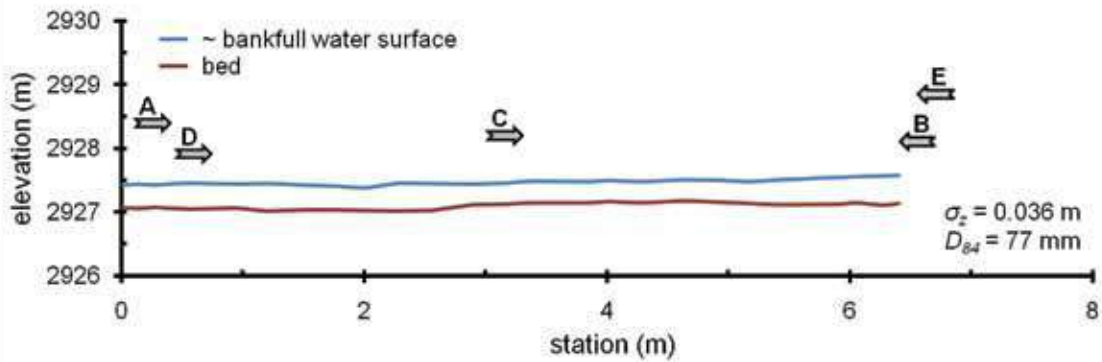
East Saint Louis Creek, Colorado, USA

$S = 0.024$ m/m; $W = 3.0$ m (9.8 ft); $L = 6.4$ m (21 ft)

Fraser Experimental Forest;
Arapaho-Roosevelt National Forest
stream classification (Rosgen): B3

longitudinal profile

~ bankfull flow

$n = 0.048$
 $f = 0.28$

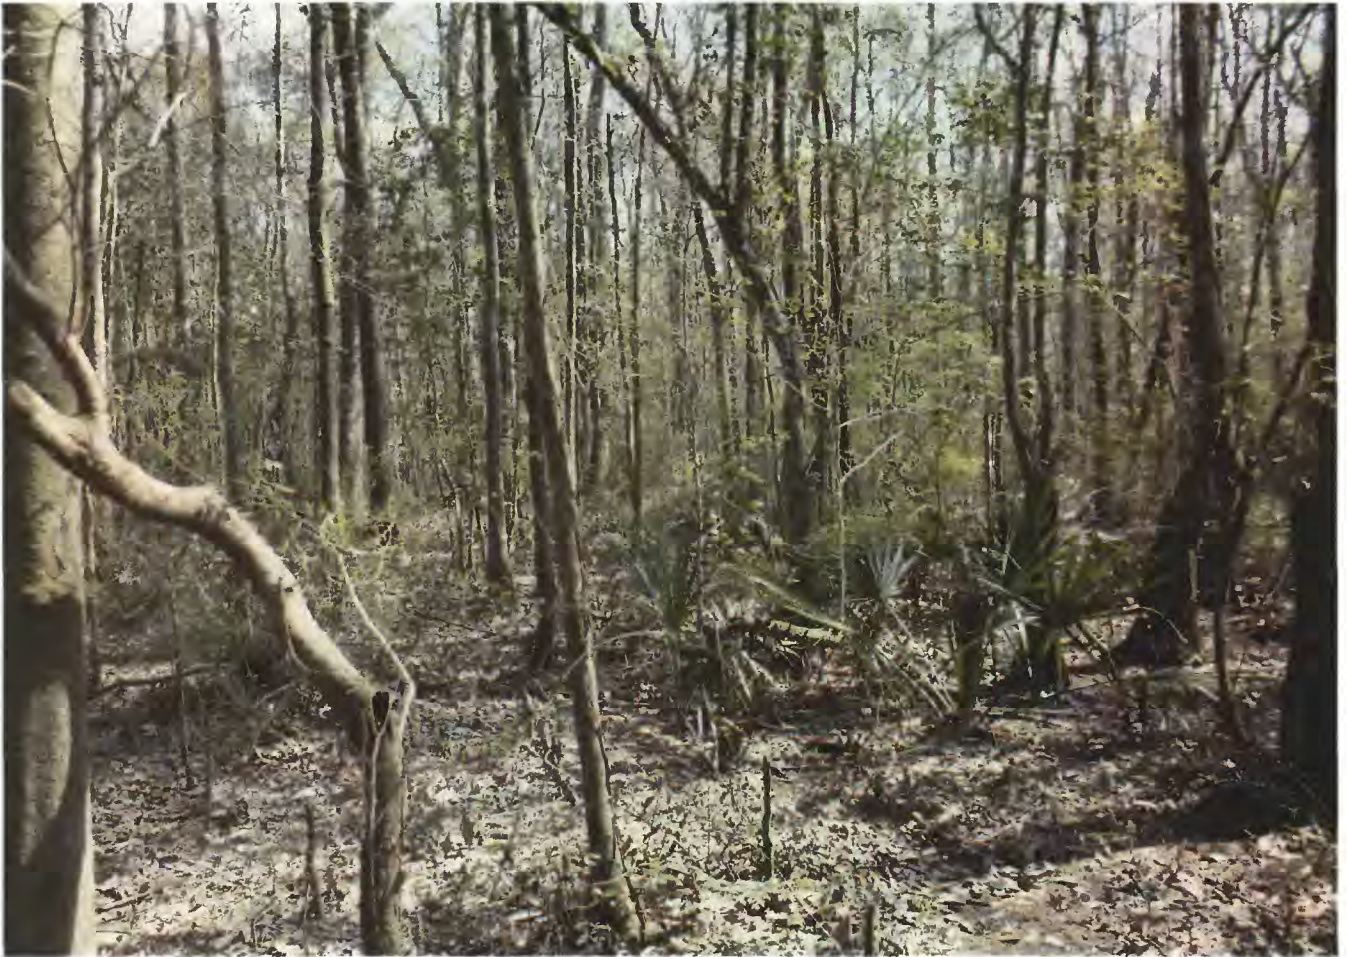
ROUGHNESS ESTIMATION FOR FOREST

**PROPOSED CHANNEL = 0.065 INCREASE
 TO ACCOUNT FOR LWM IN CHANNEL**

Computed roughness coefficient **Manning's $n=0.20$**

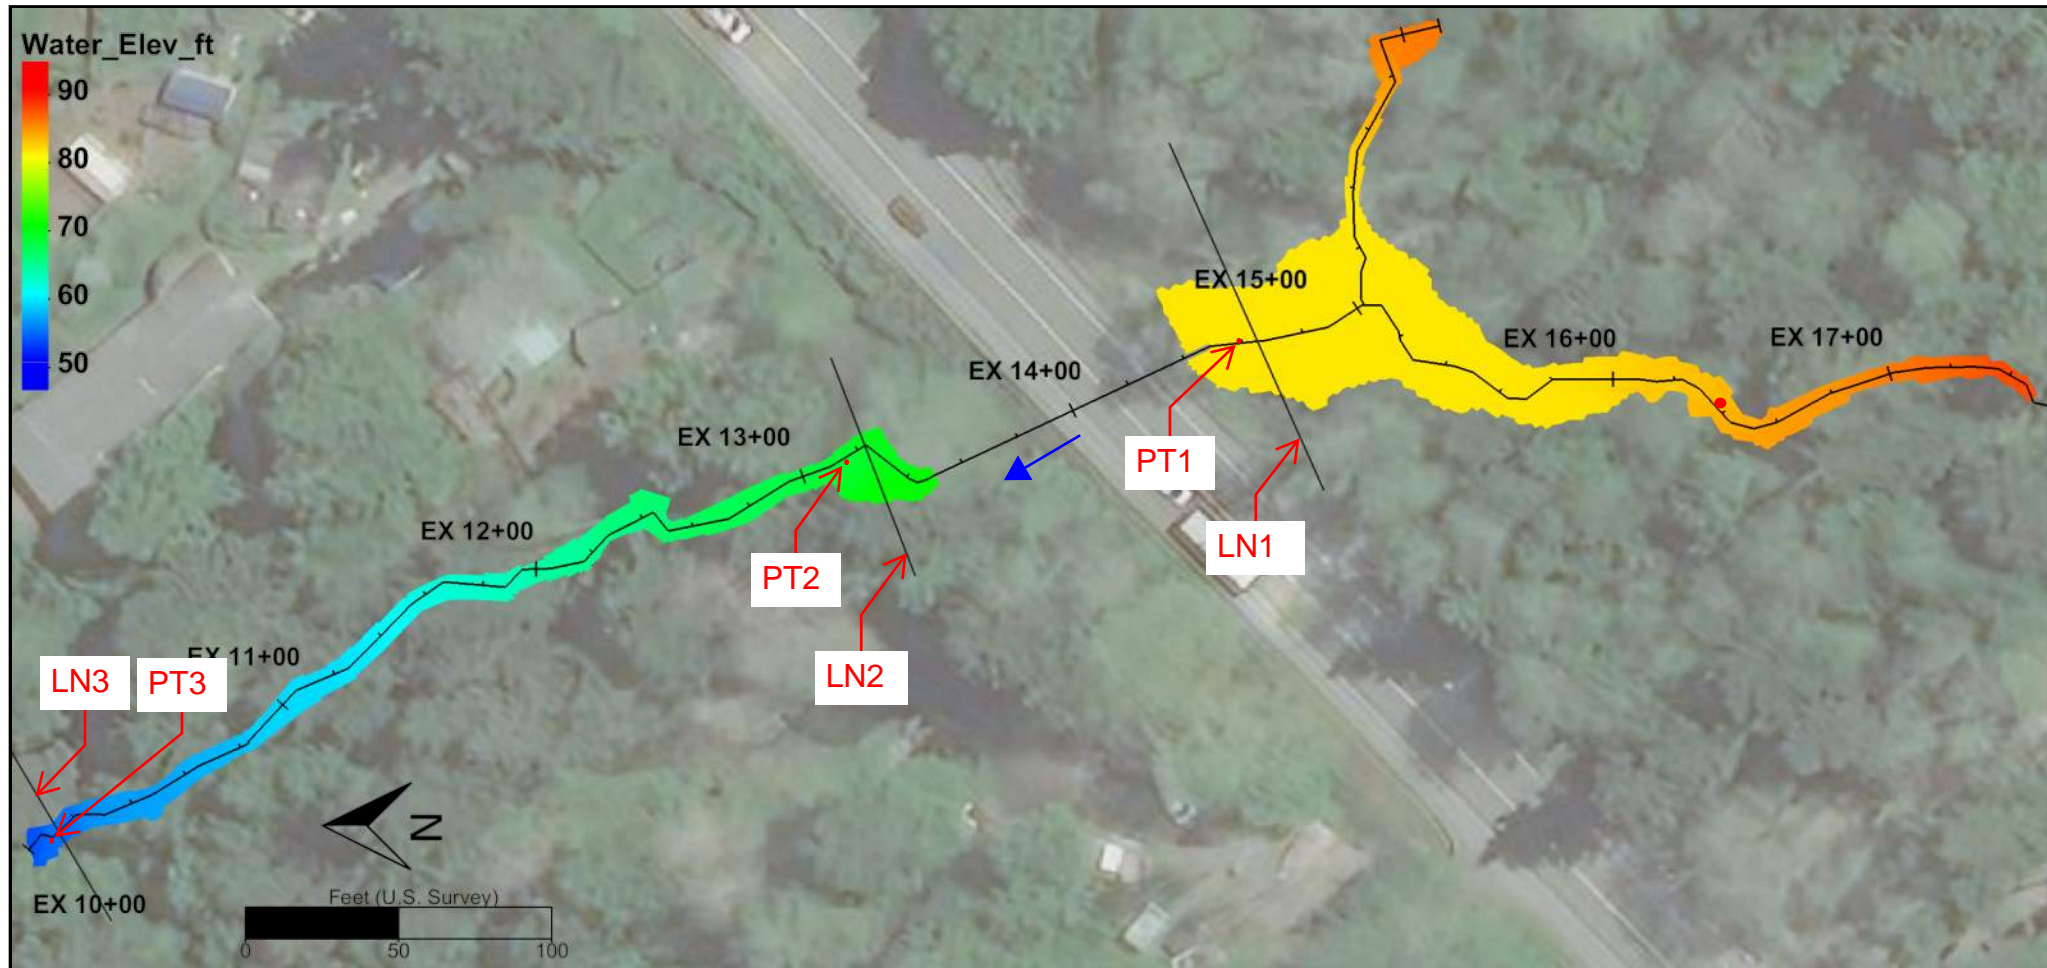
EXISTING CONDITIONS MONITOR LINE AND POINT LOCATIONS
